CORROSION EMBRITTLEMENT OF DURALUMIN  
V. RESULTS OF WEATHER-EXPOSURE TESTS

By Henry S. Rawdon  
Bureau of Standards

TECHNICAL NOTE NO. 304.

V. RESULTS OF WEATHER EXPOSURE TESTS.

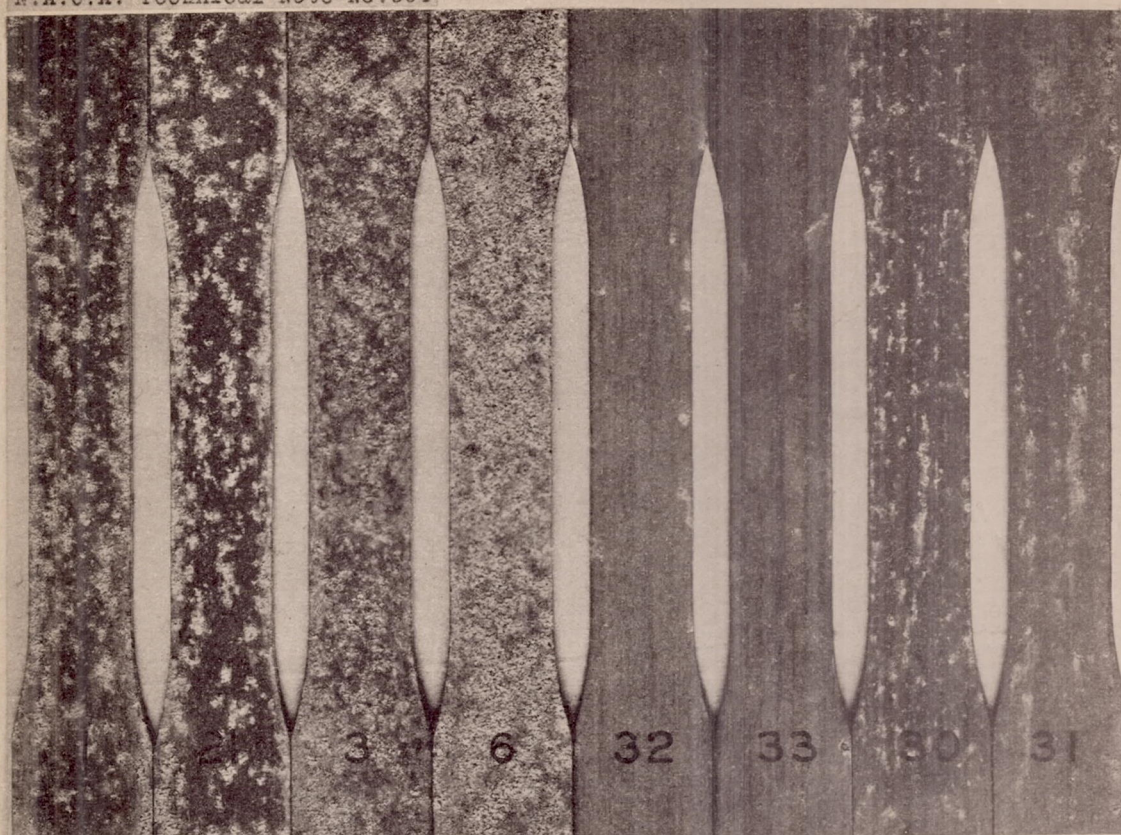
and in the Bureau of Standards exposure specimens the change was very much less marked. It is quite evident from Figure 3, without further discussion, that only in a qualitative sense can the surface appearance of the exposed bars be used as a measure of the effect of corrosion on the underlying metal.

Fig.3  
Surface appearance of representative specimens from the Coco Solo rack after 4 1/2 months exposure.

The photograph shows the under or partially protected surface of the specimens
